# DESIGN AND CONSTRUCTION OF 6-500 kV CABLE LINES. ISSUES TO BE SOLVED

Mikhail Dmitriev, PhD

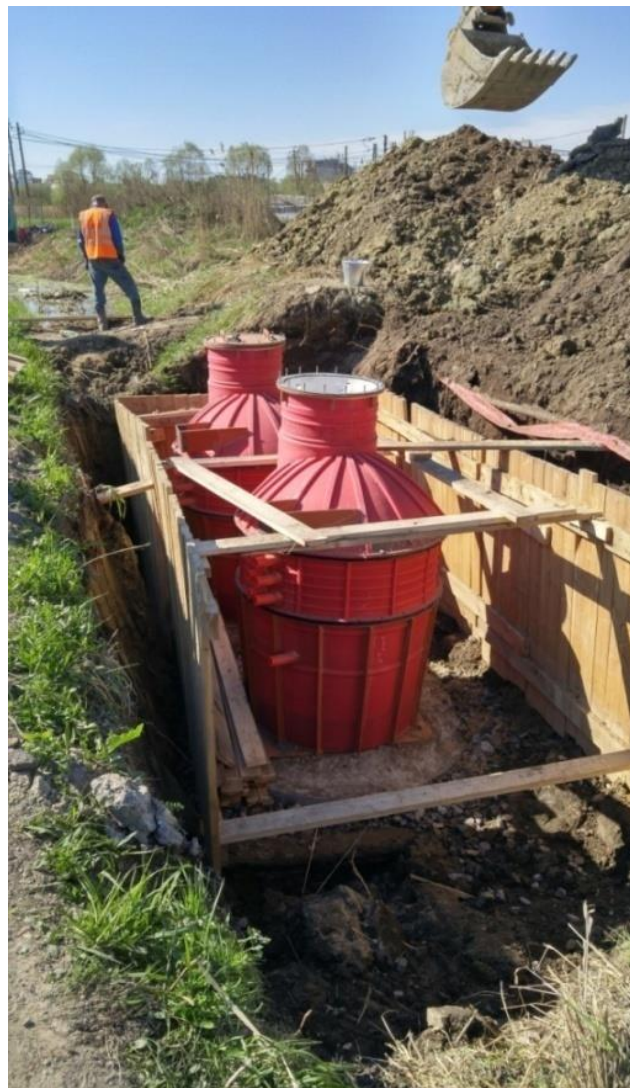
**Photo 1.** Installation of polymer wells for link-boxes.

To the greatest extent, these requirements are met by polymer cable cross-bonding wells of full factory readiness (Photo 1), which in all respects surpass traditional reinforced concrete wells that leak all the time (Photo 2) and gradually collapse (Photo 3).

In addition to solving two problems reflected in Photos 2 and Photo 3, the use of new polymer wells will allow you to get rid of another, no less urgent issue: we are talking about the safety of people when they are near the well or inside it. Currently, the well requires a grounding resistance of  $0.5 \Omega$ , which remains on paper, and at the facility, installers manage to achieve only 4-6  $\Omega$ , which is not always enough to protect people from damage by step voltage or touch voltage.

In the article [3] it was stated that the transition to polymer wells instead of concrete, will automatically ensure safety, and for a well it will be enough to have an easily achievable grounding resistance of 10-20  $\Omega$ .

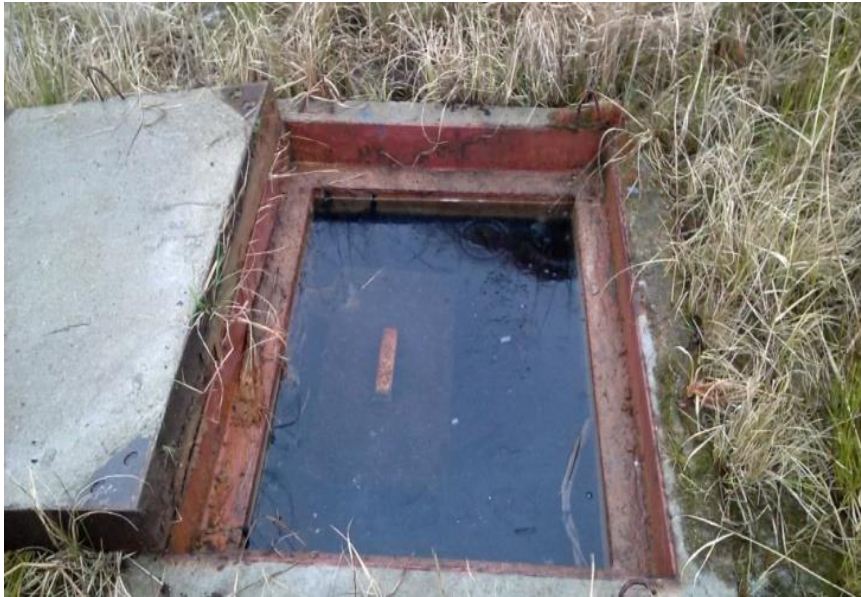
**Photo 2.** A concrete well filled with water.

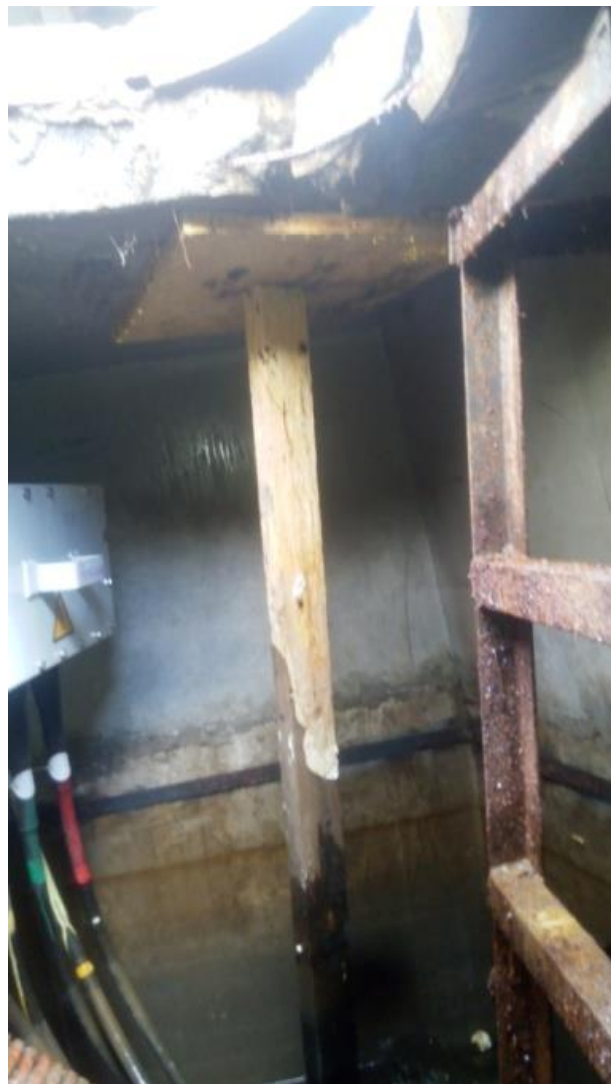
**Photo 3.** The collapse of the ceiling of a concrete well.
