TYPICAL MISTAKES WHEN PERFORMING GROUNDING OF SINGLE-CORE 6-500 kV CABLES. PART 2

Mikhail Dmitriev, PhD
info@voltplace.com

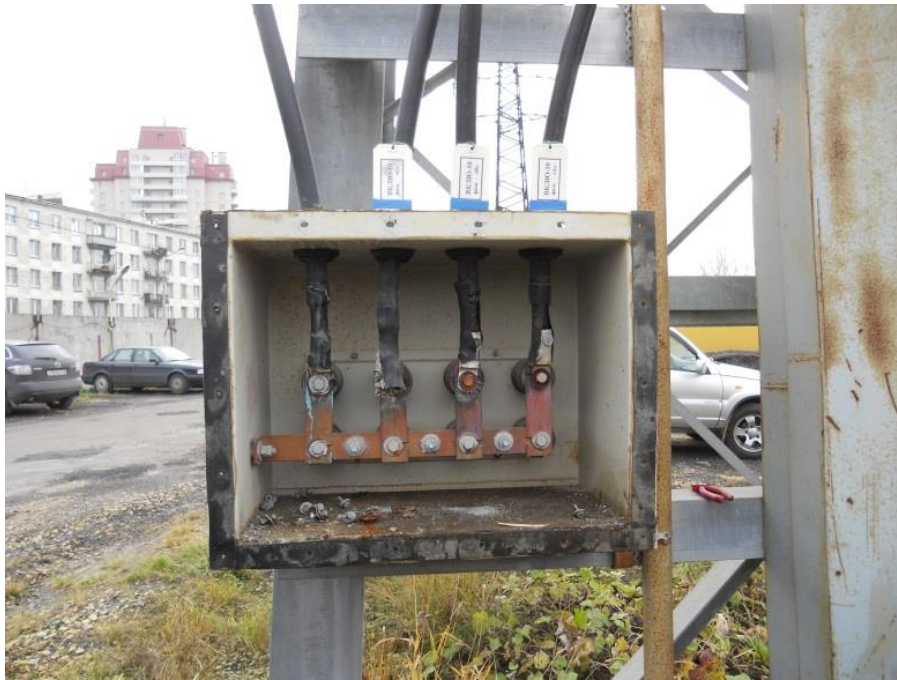
- screens of cable line entered into the box from its above, which creates conditions for moisture penetration inside the box;
- after entering the box, the copper screens of the cable line are terminated with aluminum tips, which creates conditions for electrochemical processes, increasing the resistance of the contact connection and its temperature, and contact burnout.

For example, both of these mistakes were made in the south of St. Petersburg on a 110 kV cable line, screens of which had a two-sides grounding. At one end of the cable line (on the transition tower of the overhead line – Photo 1), after a year of operation of the box, due to the ingress of water droplets from above directly onto the Cu-Al contact pair, its transient resistance has noticeably increased. This led to overheating of contacts of phases A and B by currents of 50 Hz induced in screens, loss of screens grounding of these phases on the transition tower of the overhead line. Since the screen of phase C remained grounded, the induced current (about 50-100 A) continued to flow in it, which, without compensation by currents of screens of phases A and B, fell on the housing of the box and then went into the grounding circuit of the tower. Due to the poor grounding of the box body associated with its painting, the current went into the tower through the arc (Photo 2).

Photo 1. The end link-box, where connecting wires pass from upper surface and the Cu-Al pair applied. Due to the ingress of water and electrochemical processes, screens of phases "A" and "B" burned off from the grounding bus.

2. It is necessary to prohibit the use of end cable boxes with entrances through the top cover, in order to prevent moisture penetration inside the box.
3. It is necessary to abandon the use of non-collapsible cross-bonding, which does not have boxes, and also prohibit boxes filled with compound or without support insulators.
4. It is necessary to exclude the alteration of cable joints and terminations, carefully monitor the use of joints/terminations for their intended purpose, prohibit any "kits", etc.

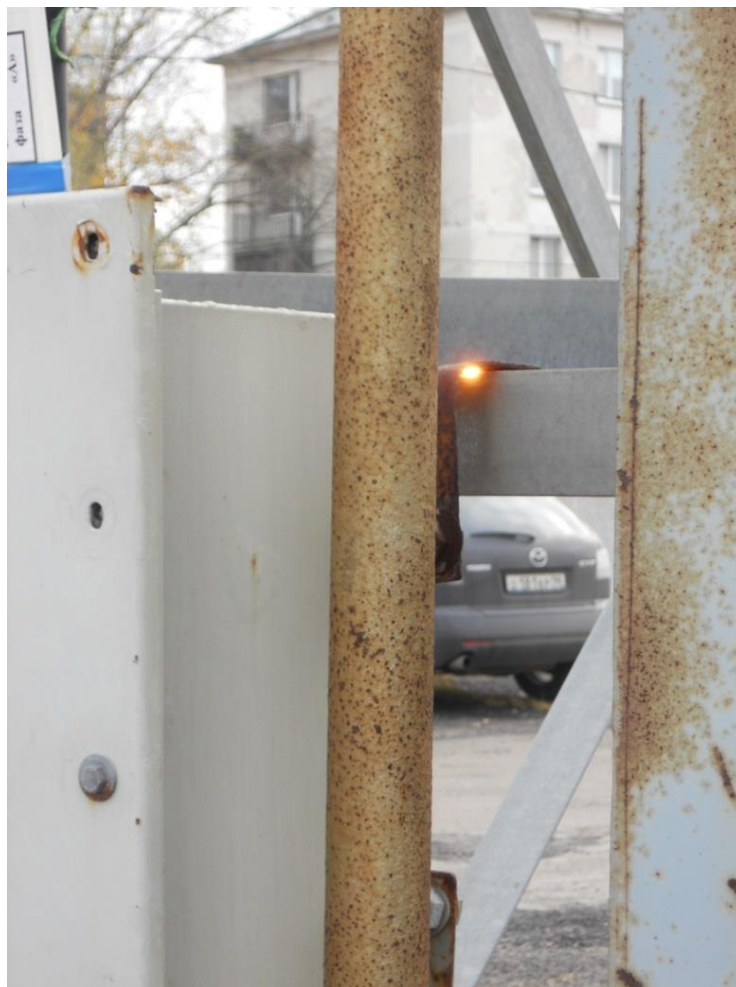
The specified regime existed for many months, posing a threat to the safety of people (step voltage) and equipment (corrosion of the tower and foundation of the overhead line).

Photo 2. Damaged end link-box (Photo 1) in the parking lot. From the housing through the arc to the body of the tower and then into the ground flows the current of the screen phase "C", which is about 50-100 A.

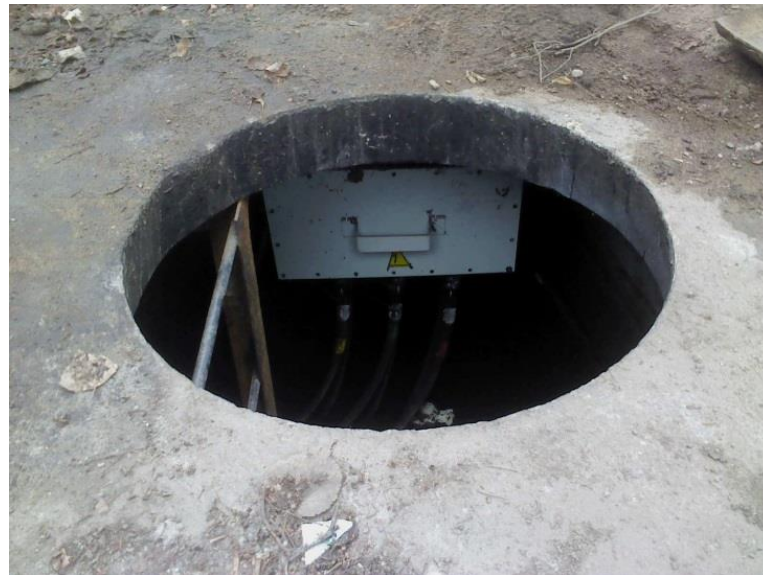
To minimize the risk of water penetration into the screens cross-bonding link-box, it is recommended to place it in the upper part of the well (Photo 3). This also allows you to perform work inside the box without pumping accumulated water out of the well and not going down into it, but simply kneeling on the ground at the mouth of the hatch. Photo 3 is noteworthy because it was taken on a 110 kV installed cable line passing under a lawn a few meters from a very busy sidewalk in the north of St. Petersburg, however:

- the well did not have a lid for a long time;
- even in the dry summer, the well was filled with water;
- the lid of the link-box is screwed with only two bolts out of 18, i.e., careless installation completely eliminates the tightness of the box and the normal operation of cross-bonding.

Photo 3. A cross-bonding link-box with two bolts instead of 18, placed in the upper part of the well.

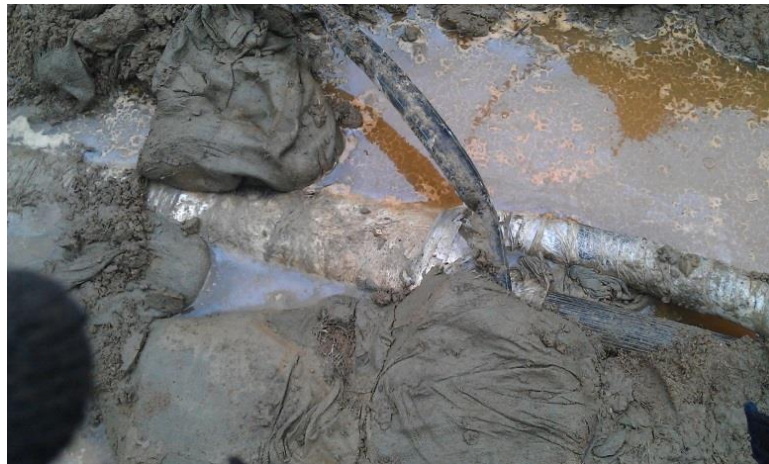
Photos 4 and 5 show one of attempts to implement a homemade screens cross-bonding of the 110 kV line. Since the need for cross-bonding was thought about after the installation of the line and connecting joints, it was decided to supplement the cable line with homemade "cross-bonding kits". As a result, the cable sheath was opened in two places along the route, screens were cut, they were attached to the core and the screen of the coaxial connecting wire, which was brought into wells and CBLB-MOA boxes hastily placed next to joints.

To seal the cable in places with an open sheath, it was wrapped with tape somewhere (Photo 4), somewhere placed in a corrugated pipe or even in wooden boxes (Photo 5) and abundantly filled with silicone both. In the XXI century, it looks wild, considering the cost of a 110 kV cable line and its installation, totaling 1 million euro per each line kilometer!

Photo 4. Homemade cross-bonding 110 kV joint. The phase of the cable is shown; the coaxial connecting wire outputs screens to outside; the scotch tape with which the place of screens output and the coaxial wire are wound. The third cable with a crease is visible from above – the output of screens of another phase.

1. It is necessary to prohibit the connection of cable joints or cable terminations with cable link-boxes using:
 - connecting wires of insulation class 0.4 kV, 1 kV, 3 kV;
 - connecting wires with a cross-section of 400 mm²;
 - coaxial type connecting wires.

The connection must be always made by a single-core connecting wire of insulation class 6(10) kV with a core cross-section equal to the power cable screen cross-section.

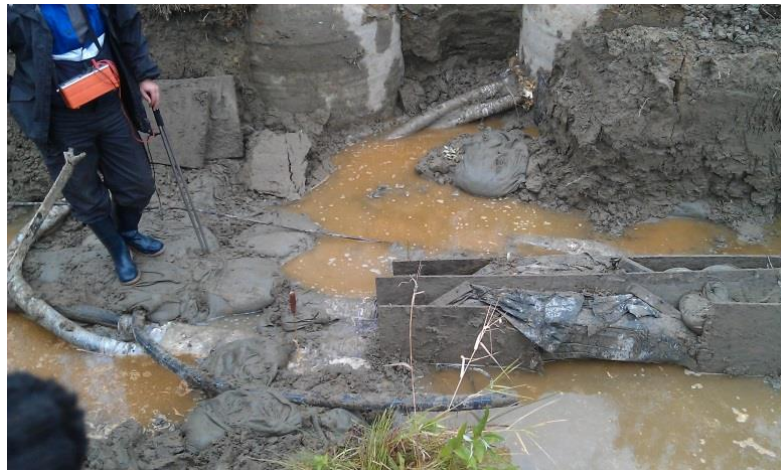
Photo 5. Homemade cross-bonding of 110 kV cable joint – plywood boxes filled with silicone and wrapped with polymer wrap.
